Intel[®] Pentium[®] III Processor Specification Update

Release Date: March 2005

Document Number: 244453-053

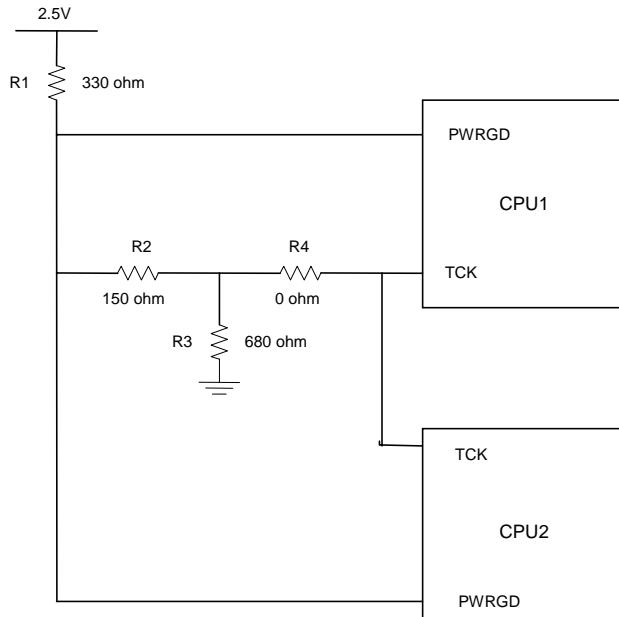
Pentium® III Processor with 512KB L2 Cache Platforms Workaround

In addition, the example workaround circuits shown do not support production baseboard test methodologies that require the use of the processor JTAG/TAP port. Alternative workaround solutions must be found if such test capability is required.

Assumes the inputs to the CPU_PWRGD are open collector signals that are Wire-ANDed together

- The example workaround circuit assumes that the PWRGD inputs into the processors are open collector. Tying the PWRGD inputs together in a Wired-AND fashion allows each processor to receive PWRGD at the same time but at the latter of the 2 separate PWRGD assertions. If separation of the PWRGD inputs to each processor is required, extra circuitry will be required.
